**Alpena Community College  
Alpena, Michigan**

**Five-Year Capital Outlay Plan  
2018-2022**

**FACILITY ASSESSMENT AND DEFERRED  
MAINTENANCE CAPITAL PLANNING REPORT  
2015 UPDATE**

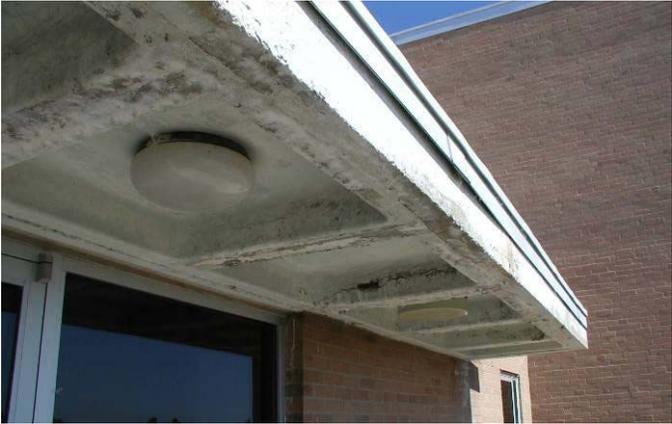
Concrete roof deterioration at the Natural Resources Center – reroofing may have stopped progression of problem.

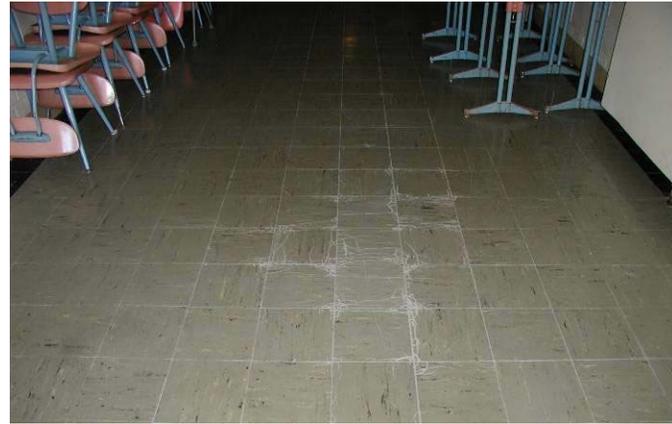
Original vinyl asbestos floor tile deterioration and adhesive failure at Van Lare Hall.

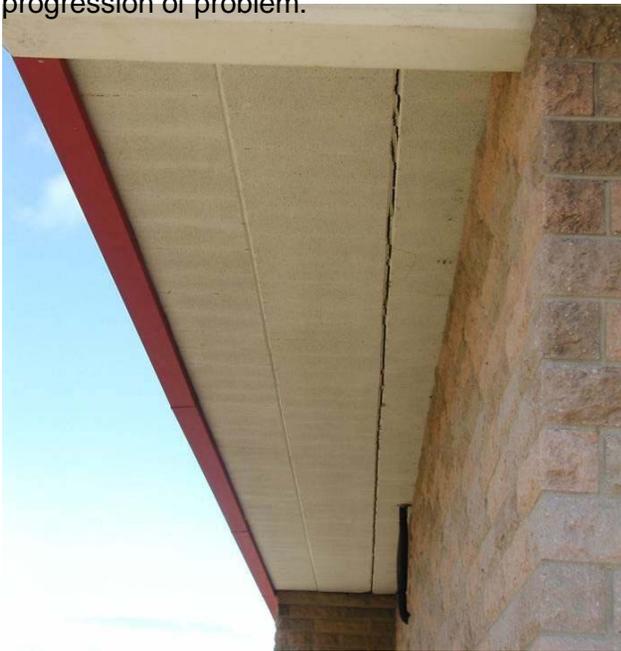
Concrete plank roof shifting at Besser Technology Center – connecting cables are suspect.

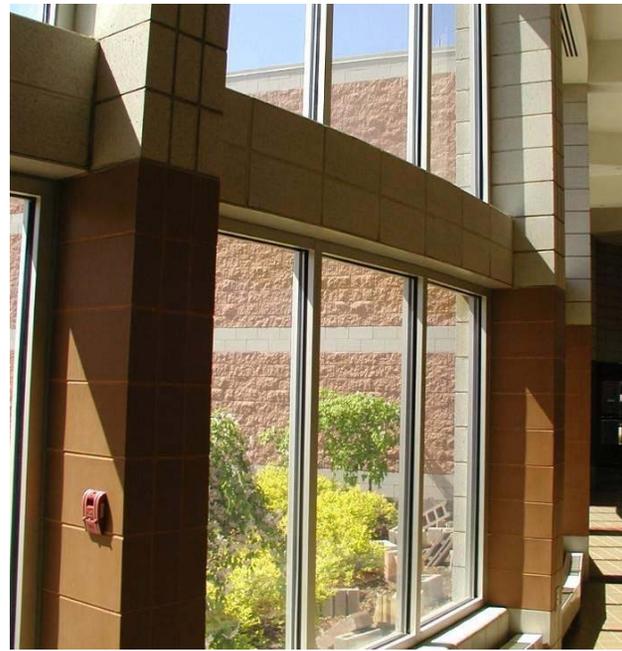
Concrete block between upper and lower windows allowing water infiltration – flashing is suspect.
