**Alpena Community College  
Alpena, Michigan**

**Five-Year Master Plan for  
Capital Outlay 2016-2020  
Submitted October 2014**

FACILITY ASSESSMENT AND DEFERRED  
MAINTENANCE CAPITAL PLANNING REPORT  
2014 UPDATE

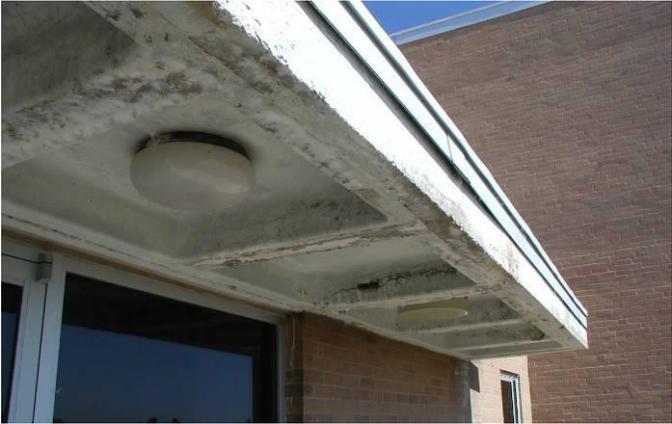
Concrete roof deterioration at the Natural Resources Center – reroofing may have stopped progression of problem.

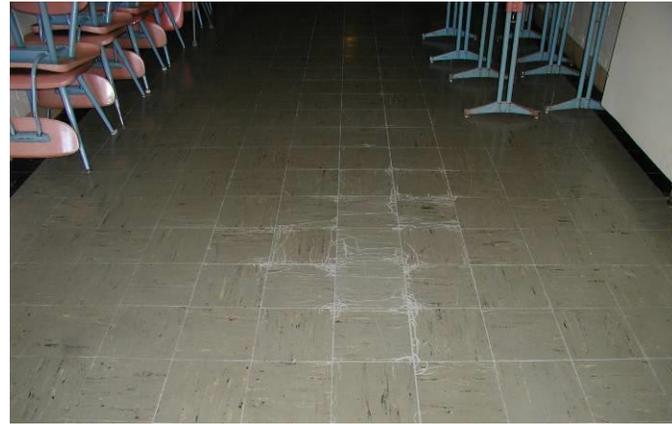
Original vinyl asbestos floor tile deterioration and adhesive failure at Van Lare Hall.

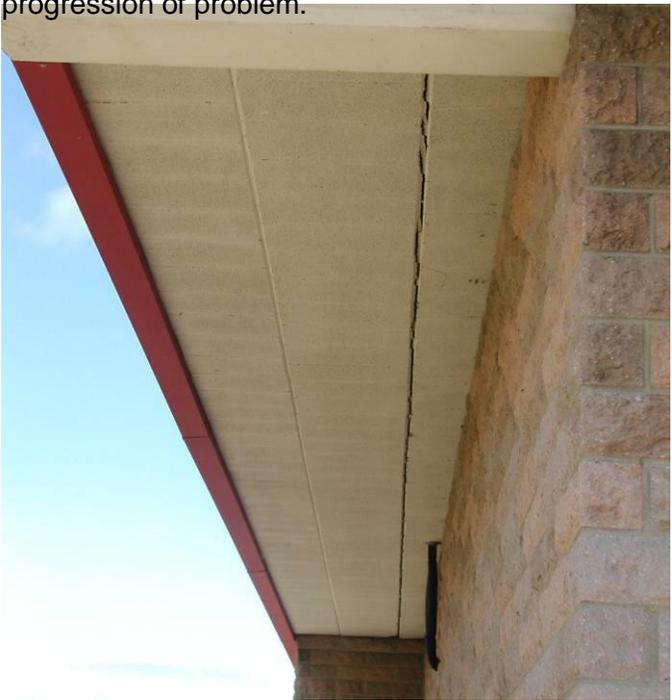
Concrete plank roof shifting at Besser Technology Center – connecting cables are suspect.

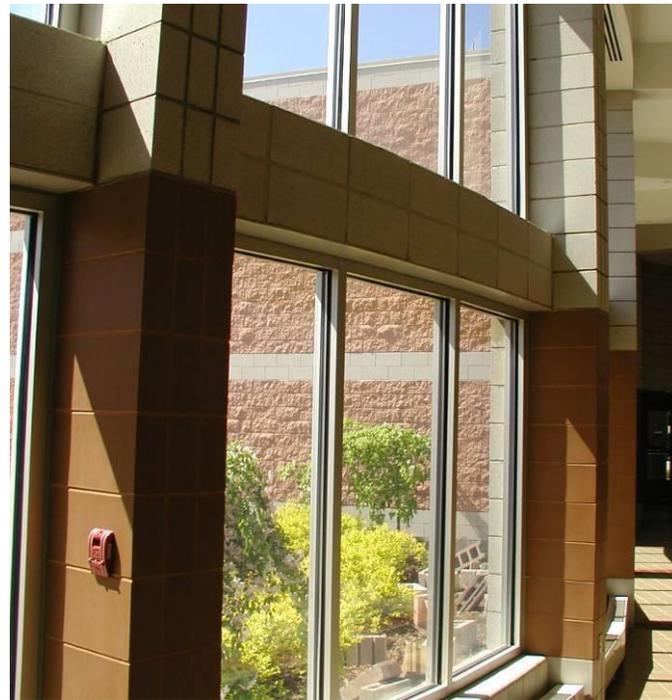
Concrete block between upper and lower windows allowing water infiltration – flashing is suspect.
