**Alpena Community College  
Alpena, Michigan**

**Five-Year Master Plan for  
Capital Outlay 2016-2020  
Submitted October 2014**

FACILITY ASSESSMENT AND DEFERRED  
MAINTENANCE CAPITAL PLANNING REPORT  
2014 UPDATE

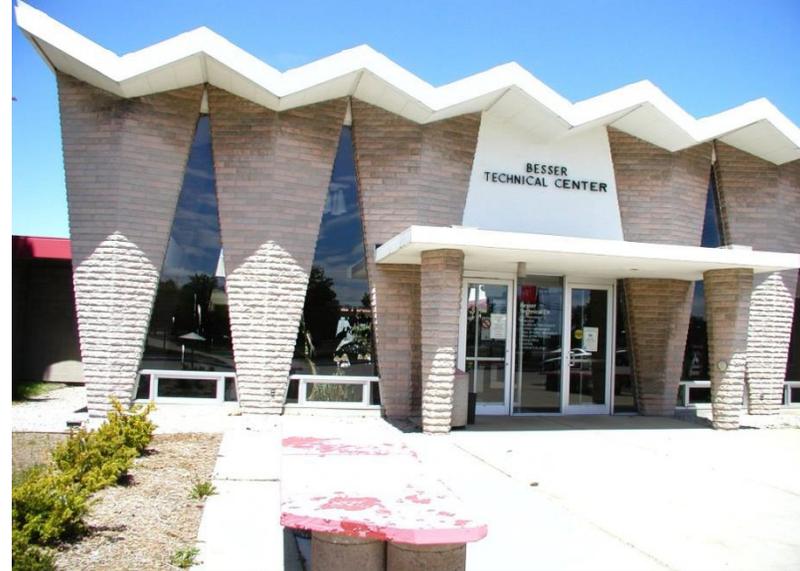
- Durolast roof installed in 2008 (Built-up roof was at end of life, leaking and due for replacement)
- Extensive cracking in east block wall at garage
- Original single pane aluminum windows at end of life. Hopper windows with hardware in poor condition. Many units fastened shut.
- Heating controls poorly coordinated, temperature difficult to control
- Fire alarm original, not ADA compliant, not monitored.
- Exterior walks have settled at entry 3 +/-, trip hazard.

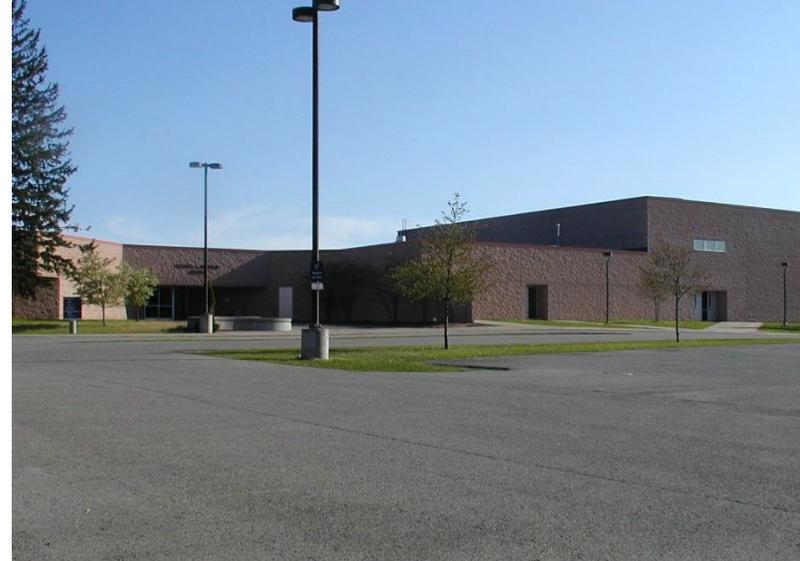
- Water infiltration at main lobby, especially at main window wall, flashing may be inadequate and weeps may not be working.
- HVAC: Bearing assembly failures on Bell & Gossett pumps
- AHU #2 (heat only) for labs 105 & 107, unit is cutting out on power overload; cause is unknown
- Power: Voltage fluctuates – usually over. Investigating supply problem with Alpena Power
- Past frequent breaker tripping problem solved by redistributing loads on panels for certain areas
- Doors: Roll-up doors – NE plant door gearbox leaks oil, SE plant door has minor forklift damage. Manual overhead door between 107 & 109 damaged by forklift and will not close
- Heaving problems at concrete pavers in front drives repaired in 2006
- Salt deterioration on bollard light fixtures at front, most lights replaced

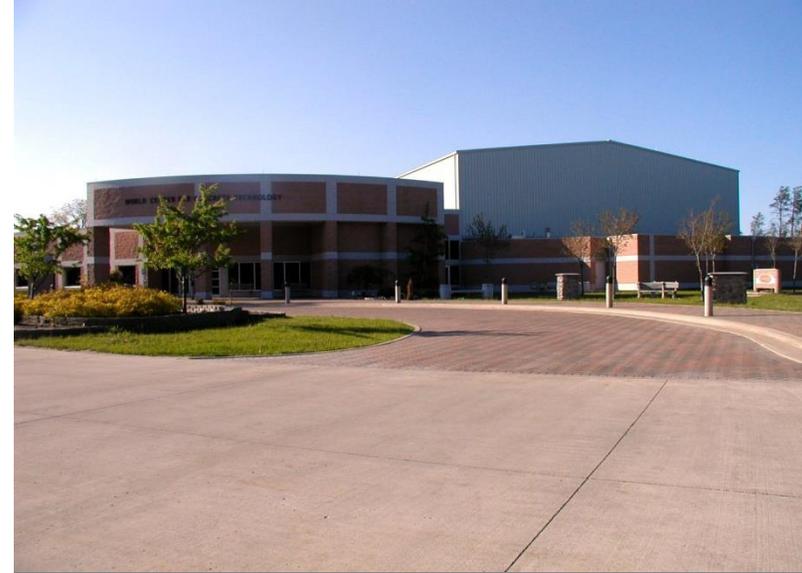
- Building new, under warranty
- Building HVAC creates negative pressure problems and concerns about proper distribution and ventilation throughout labs.
- Revolving darkroom door – not ADA accessible (only door).
