**Alpena Community College  
Alpena, Michigan**

**Five-Year Capital Outlay Plan  
2018-2022**

**FACILITY ASSESSMENT AND DEFERRED  
MAINTENANCE CAPITAL PLANNING REPORT  
2015 UPDATE**

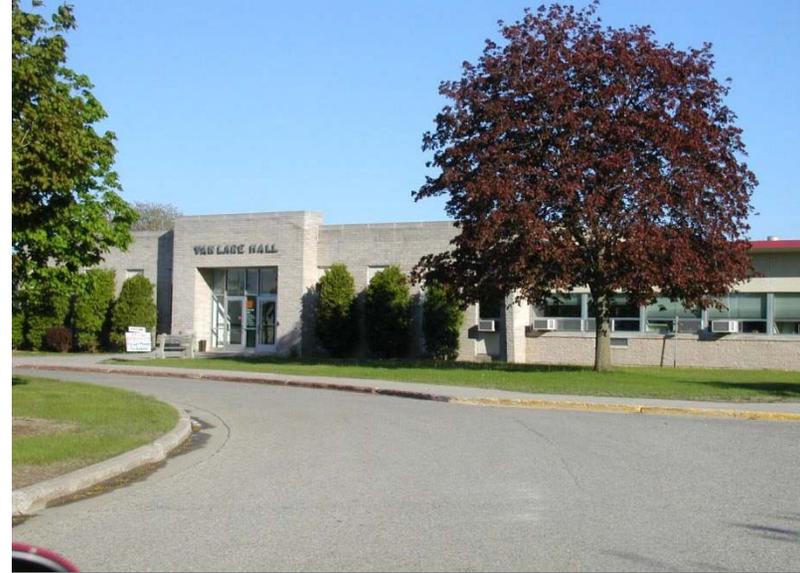
- Doors: (3) Machine shop and auto shop doors heavily rusted frames at end of life. and due for replacement
- Floors: Some terrazzo deterioration at entries, due for re-grinding

- Site: Some cracking in concrete walks. Concrete at west entry heaved, chipped.
- Some washout at roof drain outlets

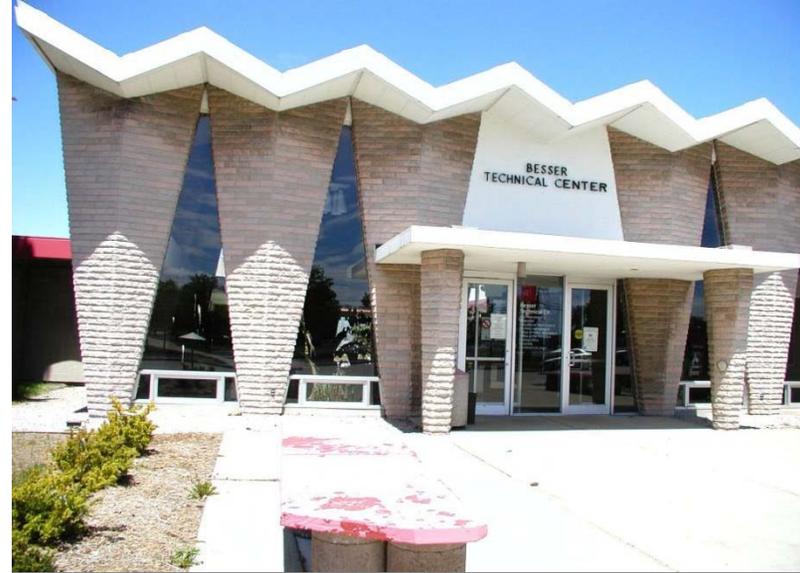
- Durolast roof installed in 2008 (Built-up roof was at end of life, leaking and due for replacement)
- Extensive cracking in east block wall at garage
- Original single pane aluminum windows at end of life. Hopper windows with hardware in poor condition. Many units fastened shut.
- Heating controls poorly coordinated, temperature difficult to control
- Fire alarm original, not ADA compliant, not monitored.
- Exterior walks have settled at entry 3 +/-, trip hazard.

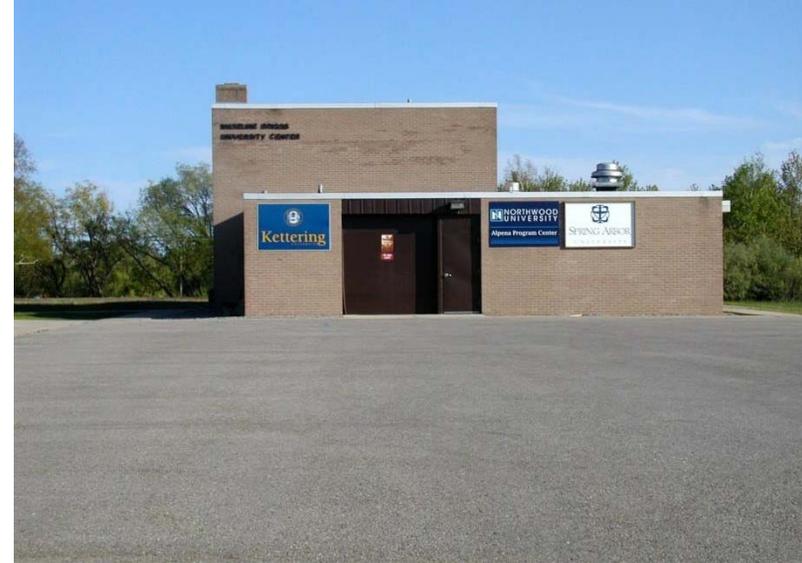
- Shut-off valves are inadequate and are added as repairs are made.
- Some distribution panels at or near capacity. No reported problems.
- Walls on level one and two repainted summer 2009.

- Spalling/ cracking of concrete waffle slab overhang and balcony floor at fourth floor boardroom, reinforcing exposed.
- Cracking on concrete cap on seatwall next to site ramp.

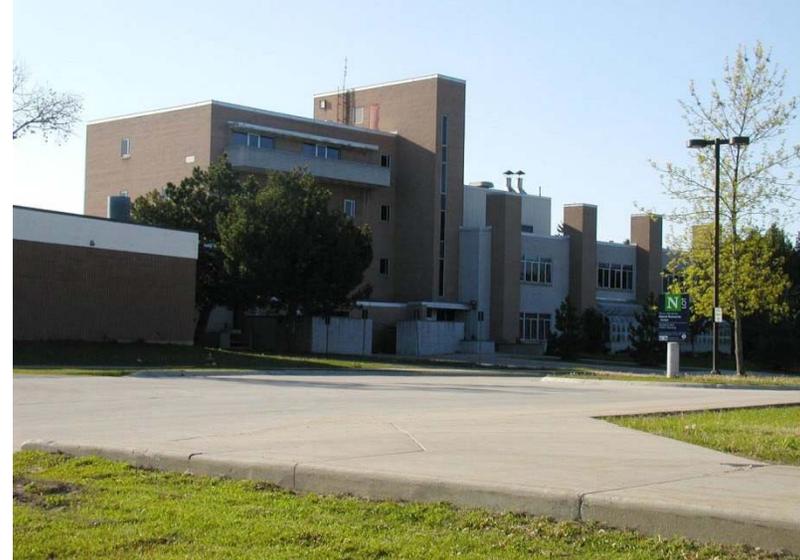
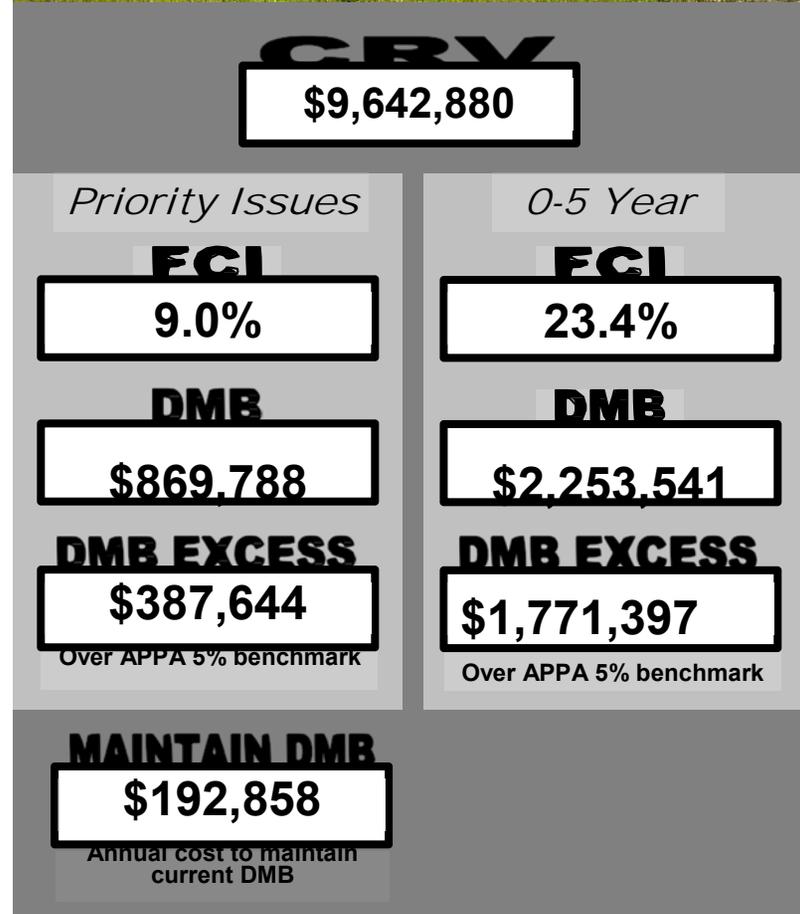
- Glazing gasket on interior of windows popping out – pushed back in place on a regular basis.
- AHU #6 at the arena is not working due to relay failure, AHU #5 is handling the load alone

- Fire suppression riser leaking at valve M168, likely packing failure
- Hollow metal service doors of auto body shops and arena rusting at bottom
- Carpet in wellness center entry shrinking and pulling at seams, potential trip hazard.

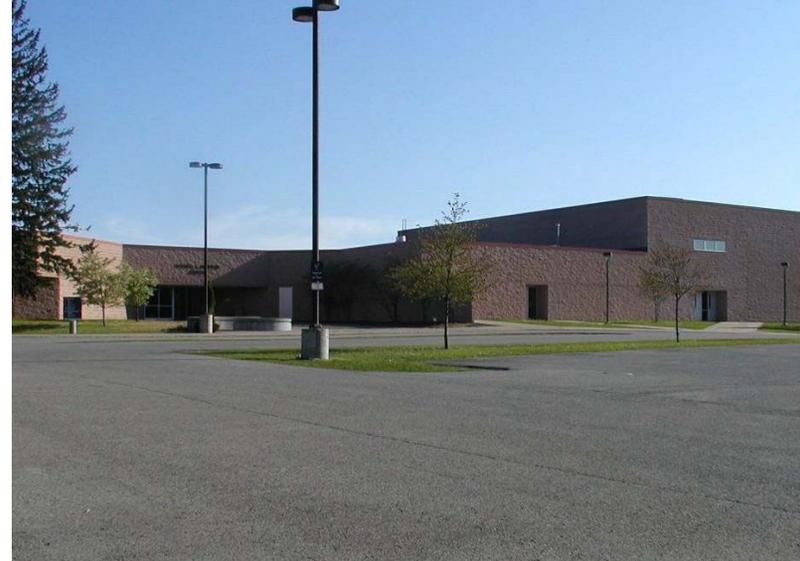
- Water infiltration at main lobby, especially at main window wall, flashing may be inadequate and weeps may not be working.
- HVAC: Bearing assembly failures on Bell & Gossett pumps
- AHU #2 (heat only) for labs 105 & 107, unit is cutting out on power overload; cause is unknown
- Power: Voltage fluctuates – usually over. Investigating supply problem with Alpena Power
- Past frequent breaker tripping problem solved by redistributing loads on panels for certain areas
- Doors: Roll-up doors – NE plant door gearbox leaks oil, SE plant door has minor forklift damage. Manual overhead door between 107 & 109 damaged by forklift and will not close
- Heaving problems at concrete pavers in front drives repaired in 2006
- Salt deterioration on bollard light fixtures at front, most lights replaced

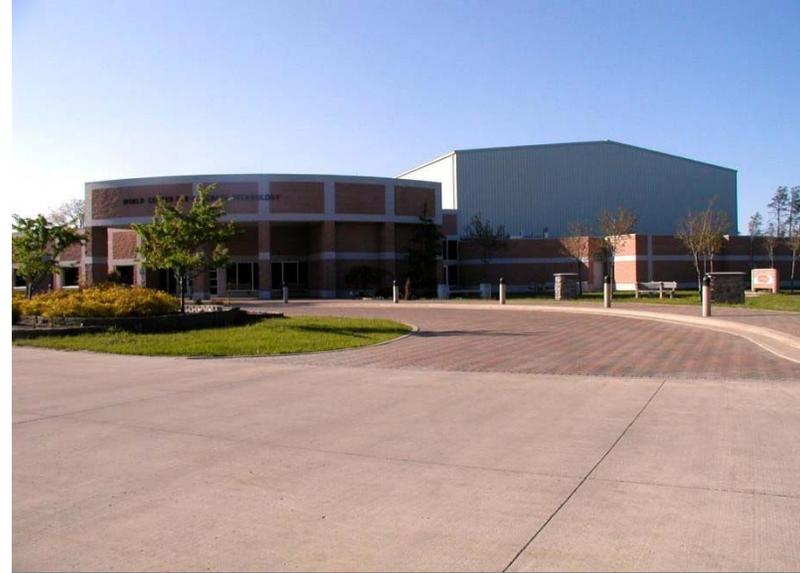
- Building new, under warranty
- Building HVAC creates negative pressure problems and concerns about proper distribution and ventilation throughout labs.
- Revolving darkroom door – not ADA accessible (only door).

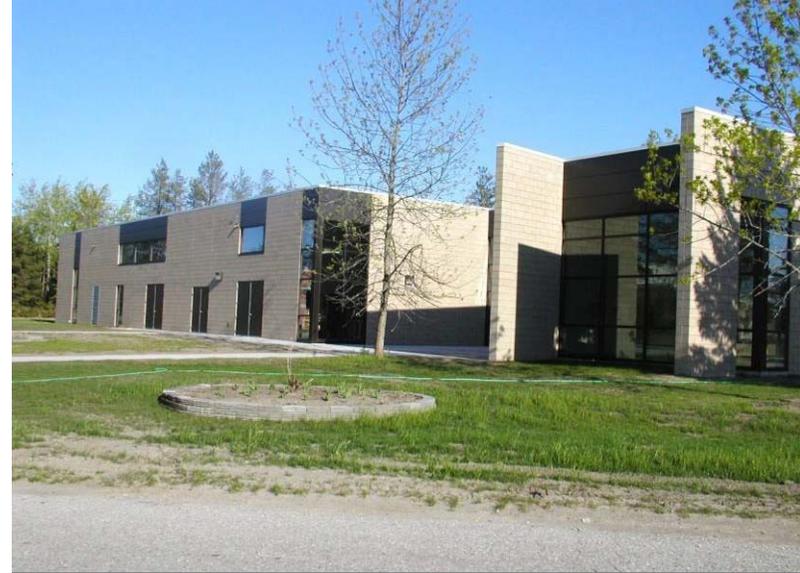
- Interior doors: Finish scratched and veneer damage, most doors have holes where parts were removed
- Carpet replaced throughout first and second floor with the exception of a few offices

- Emergency and Exit lighting - Several not working.
- Treads in poor condition on some stairs, especially front entry stair
- Front entry steps nosings missing or loose.
